HURRICANE FLORA DAMAGE
TO THE CUBAN TRANSPORTATION SYSTEM
REPAIRED RAPIDLY

CIA/RR CB 63-96

29 November 1963

CENTRAL INTELLIGENCE AGENCY

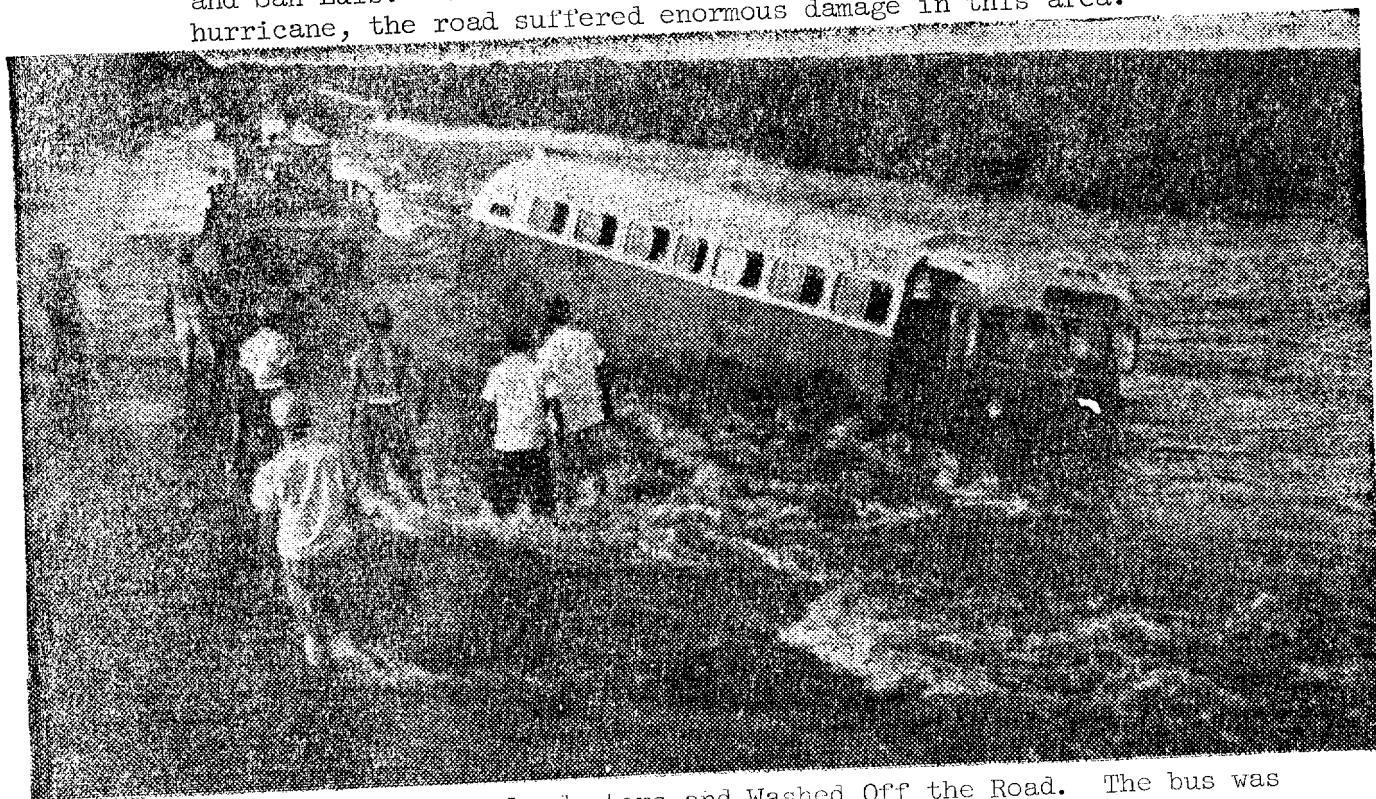
Figure 4. Bus Picked Up by Floodwaters and Washed Off the Road. The bus was washed off the road while trying to aid in the evacuation of the area around Camaguey.
